## **HSC® COATING WITH TOP COAT OF RUST GRIP®**

**2011**

Laiken SA, Argentina

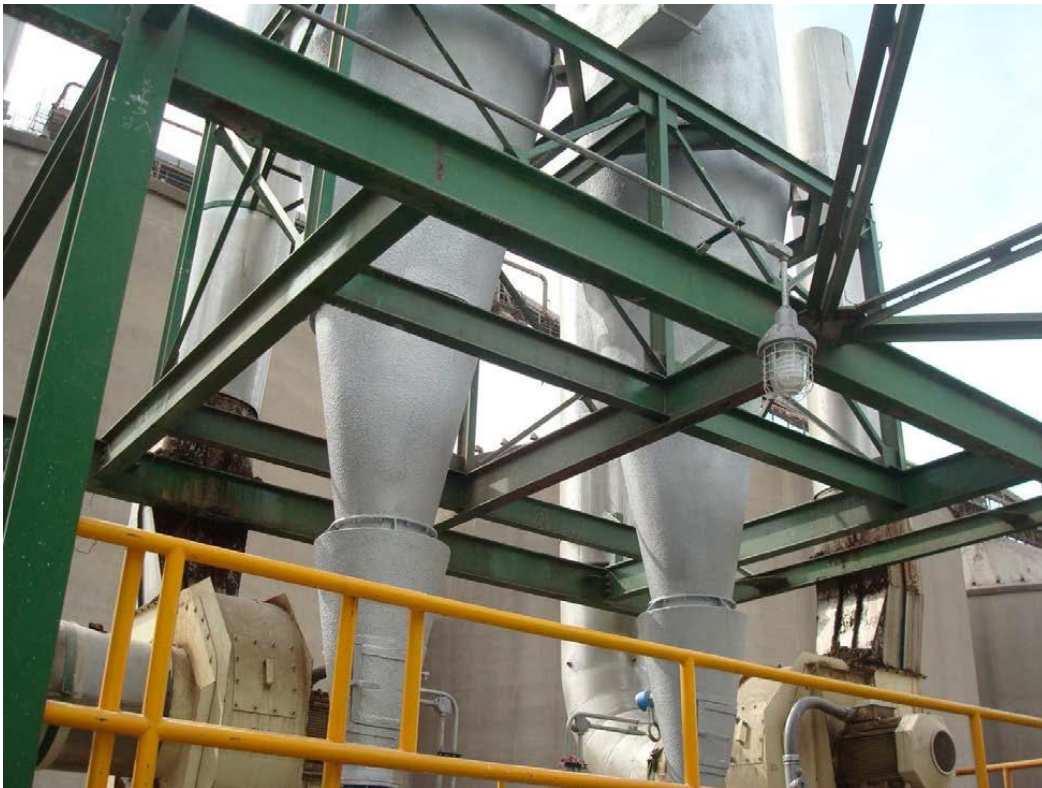
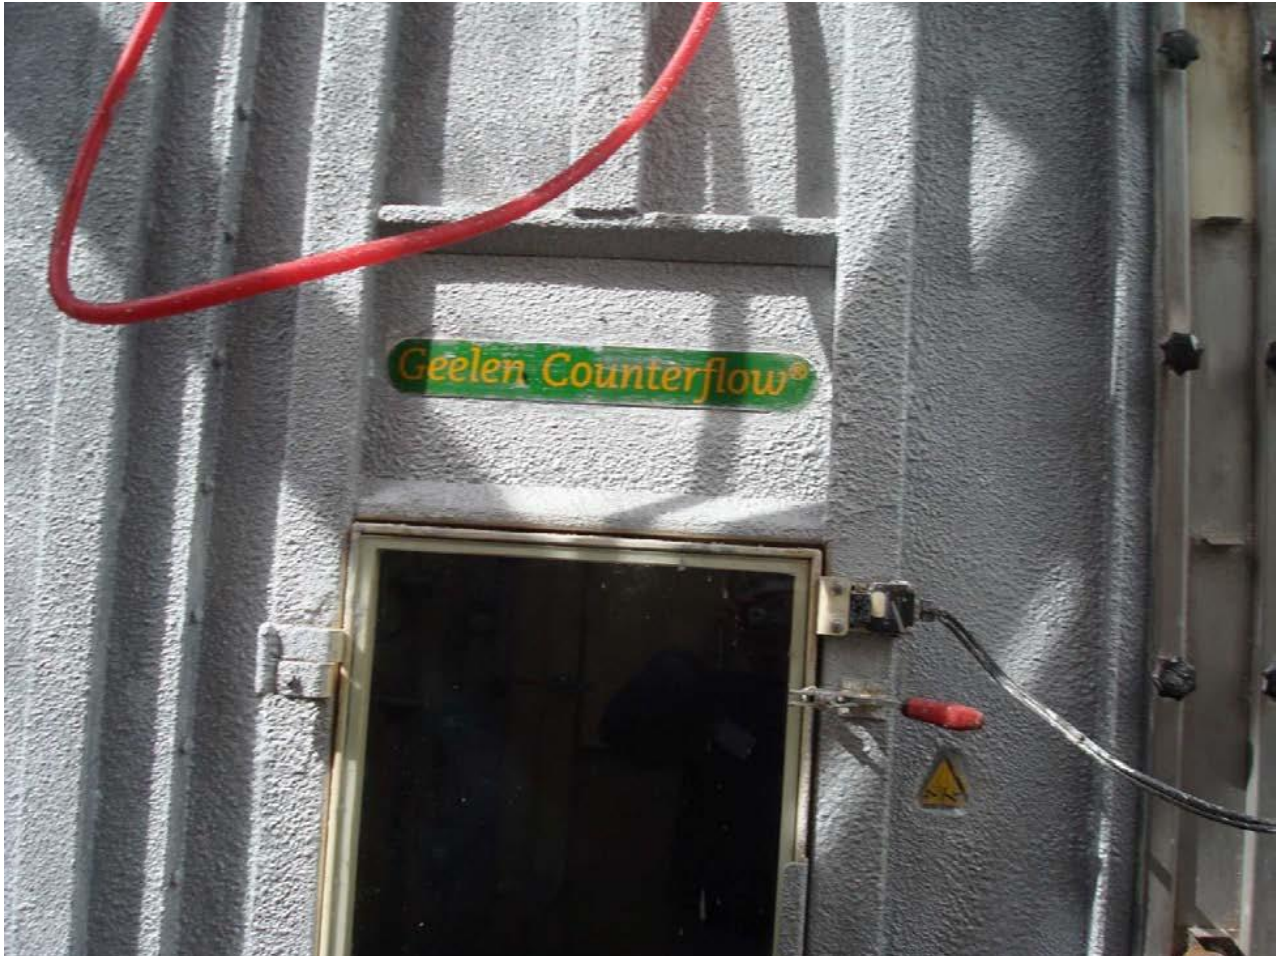
We just finished a nice job. This work was performed on a cereal company that processes soybeans. They have lots of dryers for drying of soybean flour. In these dryers, hot air passes through the wet flour. While the flour dries, the air is loaded with moisture, and cools.

There are 2 types of problems associated with thermal insulation:

- 1 - Loss of energy in the area where the hot air enters the system at 160°C / 320°F
- 2 - Condensation on the metal walls as the air cools.

A contractor under our supervision, applied **HSC® Coating** and **RUST GRIP®** as external protection. They applied 80 mils to 160 mils dry depending of the problem in each area.

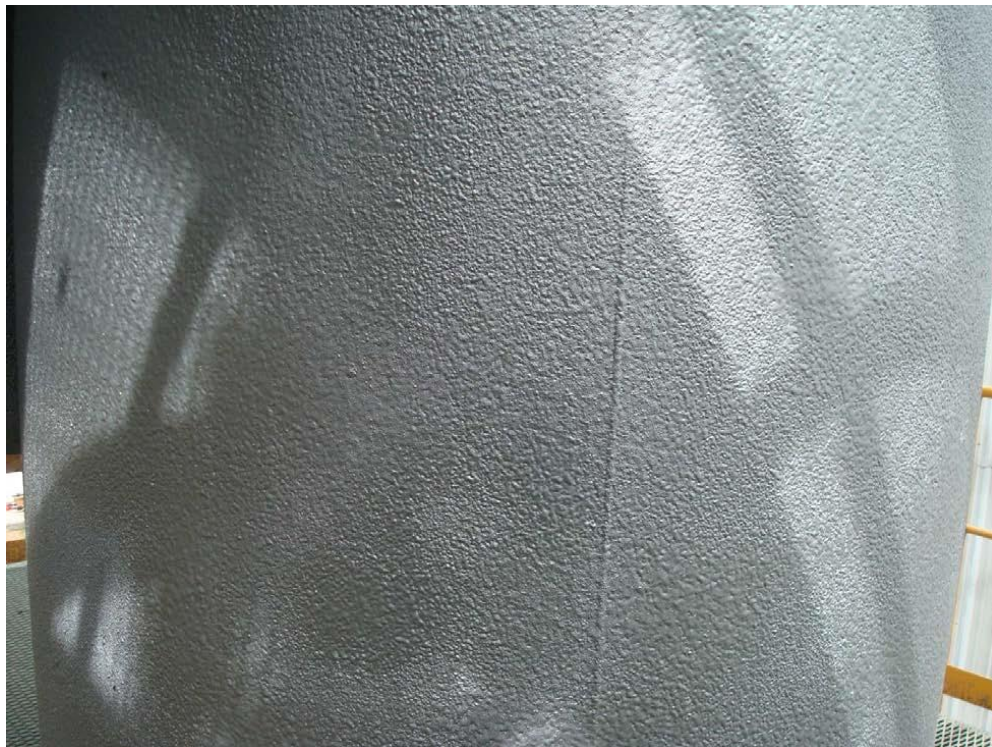
The company has more than 5000 square meters with these problems, and decided to do a test on a dryer that has approximately 400 sqm (Geelen Counterflow Dryer). This is what you see in the pictures attached.

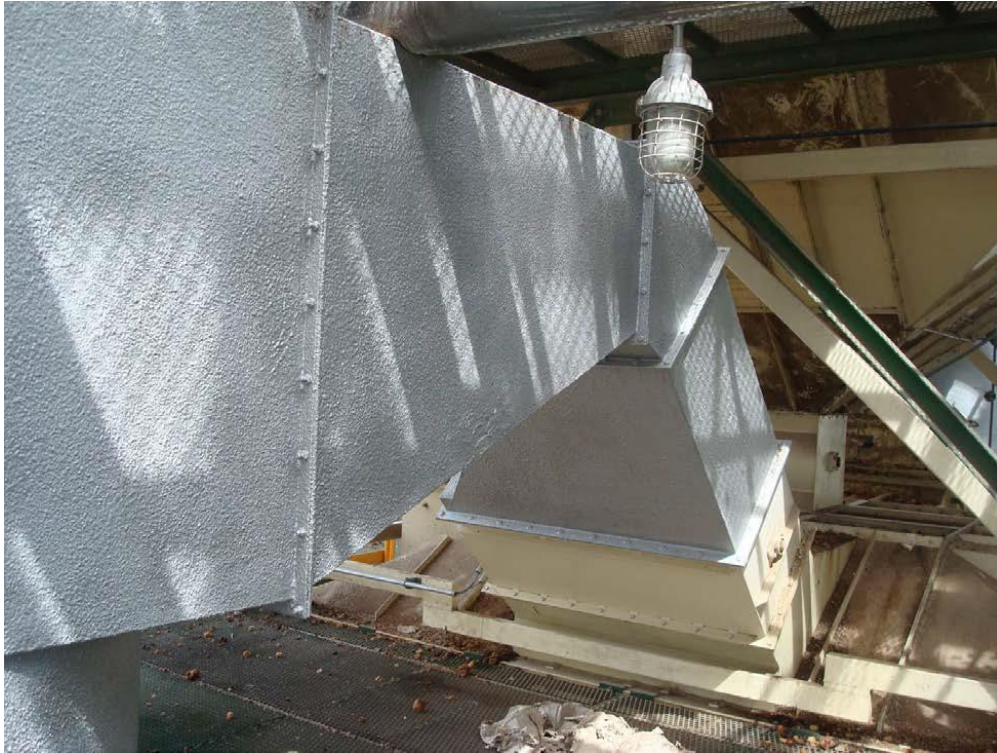
We applied with hopper guns, one Graco and the other one a Texture Pro from Wall Board Tools. **RUST GRIP**® was applied with a brush.

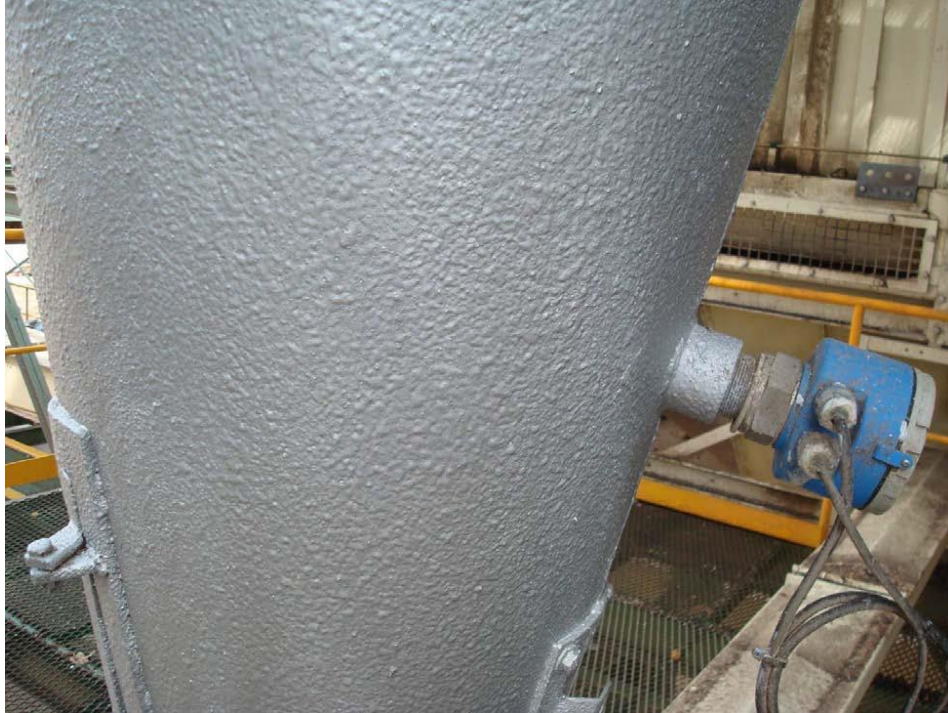
The trial was successful and now they want to coat the remaining +5000 square meters. Project Pictures  
Courtesy of: Juan Martín Laiken SA [jmolaciregui@laiken.com.ar](mailto:jmolaciregui@laiken.com.ar)
